# REPORT 1363

## ORIGIN AND PREVENTION OF CRASH FIRES IN TURBOJET AIRCRAFT<sup>1</sup>

By I. IRVING PINKEL, SOLOMON WEISS, G. MERRITT PRESTON, and GERARD J. PESMAN

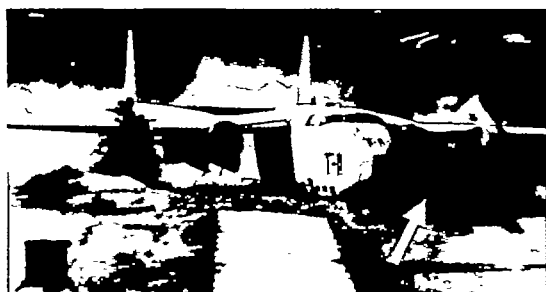
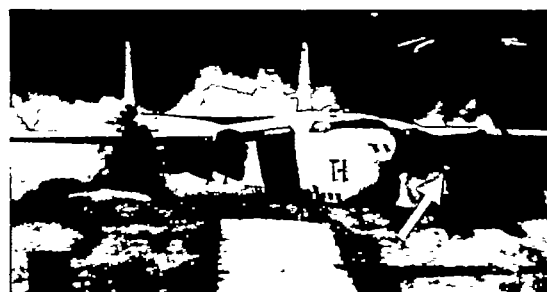
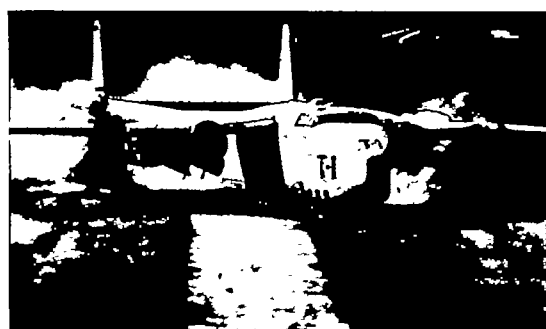
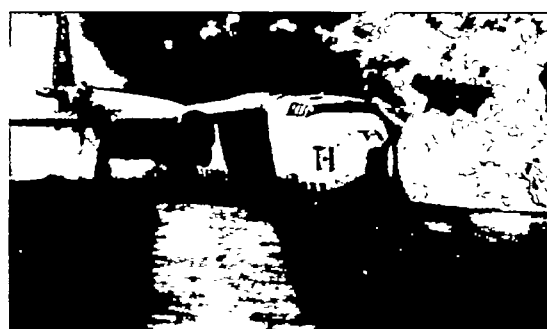
FIGURE 2.—Development of crash fire in simulated jet bomber.

(c) Fuel mist entering left engine, 2.5 seconds after initial impact.

(d) Fire at engine inlet and tailpipe of left engine, 2.6 seconds after initial impact.

(e) Fire spread to fuel mist issuing from left wing, 2.8 seconds after initial impact.

Flames originating within the engine may also appear at the engine inlet as observed in figure 2(d). The appearance of this inlet flame may be explained in the following way. Burning of ingested fuel in the combustor flame reduces the turbine-inlet gas density. A higher pressure in the combustor is required to pass the gas through the turbine. When an abrupt change in over-all combustor fuel-air ratio is provided by the ingested fuel, the pressure in the combustor required to pass the combustor gas through the turbine may exceed the capability of the compressor at the existing rotor speed. The compressor flow may stall before the turbine can accelerate the rotor to a speed that will provide the necessary pressure. At this moment the combustor flame may propagate upstream through the ingested combustible mixture that fills the stalled compressor and exit at the engine inlet.

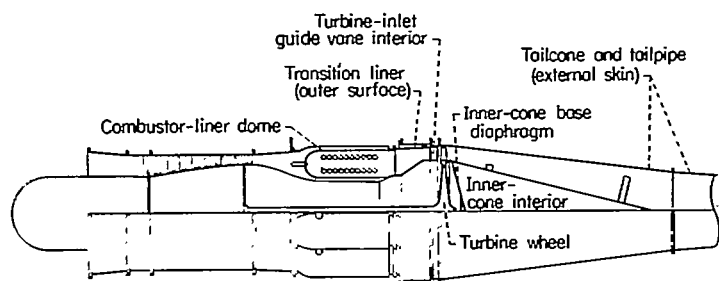
FIGURE 11.—Hot-metal ignition sources found in J35 engine.

The ignition zones were identified in test-stand engines by the method discussed in detail in appendix C. The technique employed involved the use of fuel sprays local to the engine zone suspected as an ignition source. Following engine operation at rated conditions for a time sufficient to establish temperature equilibrium, the fuel flow to the combustor was turned off and the fuel spray was turned on local to the zone under study. The fuel flow was programmed to maintain a combustible atmosphere in the zone. If ignition occurred, inerting means were installed to prevent the ignition in subsequent tests of upstream zones. By starting at the downstream end of the engine and proceeding upstream in this way, each ignition zone was identified and inerted in turn. As a final check after all the zones were inerted, fuel was injected into the main gas stream to determine whether ignition would occur. In this manner, ignition zones were found on the combustor liner, transition liner, turbine, inner cone, and tailcone and tailpipe (fig. 11).

Combustor liner: The ignition zone found on the combustor liner was the dome, which lies close to the primary

combustion zone. The metal adjacent to the dome is heated by the combustor flame and attains unsafe temperatures in spite of the cooling provided by the adjacent air. Also, in this region the engine air is caused to recirculate by design to provide a zone of low transitional speed and promote good combustion. Both the hot metal of the combustor liner adjacent to the dome and the residual flames previously discussed make this zone particularly hazardous. The size of this zone is difficult to define, since it depends on the air temperature at the compressor outlet, the combustor design, and the ignition characteristics of the combustibles sucked into the engine.

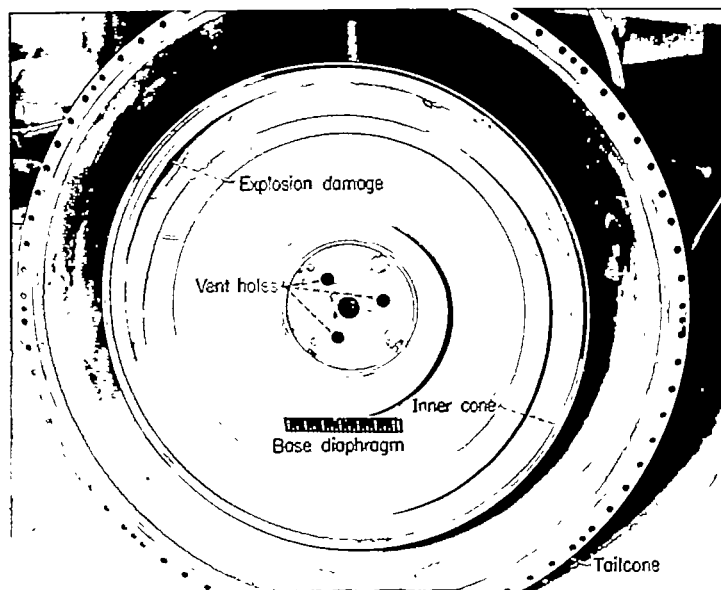
FIGURE 12.—J35 Inner-cone base diaphragm.

**Inner cone:** Combustible atmospheres delivered to the turbine wheel from the compressor can enter the interior of the inner cone through vent holes. In some engines these vent holes are located at the base of the tailcone as shown

in figure 12. The plane of the inner-cone base is parallel to the turbine wheel. Combustibles entering the cone could ignite on the hot walls of its quiescent interior. The slight damage to the base diaphragm, indicated in the figure, followed ignition in the interior. The resulting flame might ignite the combustible atmosphere streaming through the engine to produce the dangerous flames at the engine inlet and tailpipe shown in figure 13.

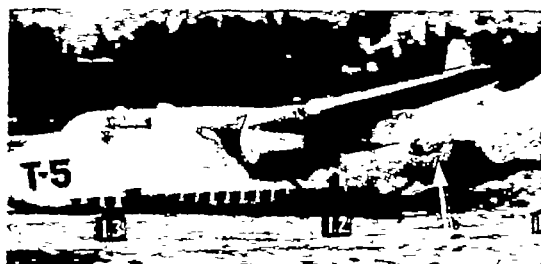
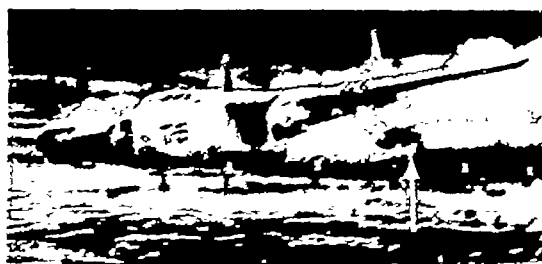
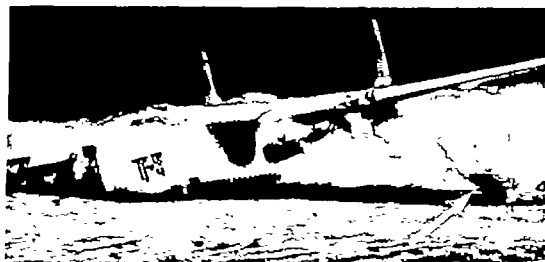
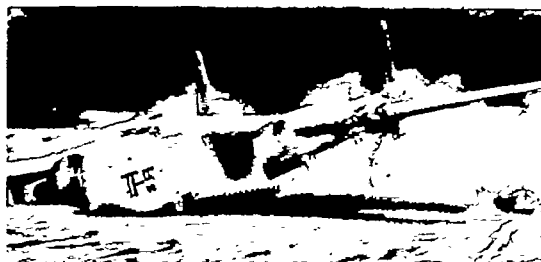
FIGURE 24.—Separation of J47 engine from C-82 wing in crash.

wake of the damaged wing (figs. 24(b) and (c)) and came to rest in the fuel-wetted slide path of the airplane (fig. 24(d)). The plume of condensed water vapor at the tailpipe (fig. 24(b)) shows that the water inerting system was actuated. No fire occurred.

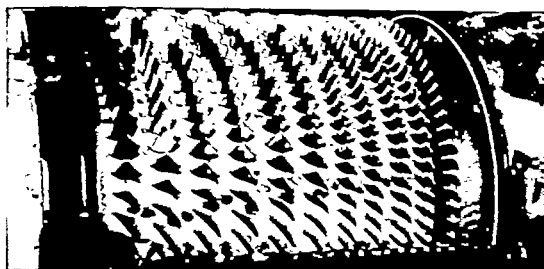
The sequence of events following crash was the same for the F-84 as for the cargo airplanes. Poles at the crash barrier ripped open the wing fuel tanks and produced the fuel mist shown in figure 25(a). Collapse of the nose gear allowed fuel from the torn forward fuselage tank to enter the engine inlet. Vapor issuing from the tailpipe (fig. 25(b)) was provided in part by the fuel that passed through the engine from the damaged fuel tank adjacent to the engine inlet. Evaporation of water from the fire protection system contributed a large part of the vapors formed (fig. 25(b)). Inspection of the engine after crash showed the telltale dye stains left by the red-dyed fuel flowing through the compressor (fig. 26). No fire occurred.

FIGURE 26.—Fuel-dye stains on J35-engine compressor following F-84 crash.

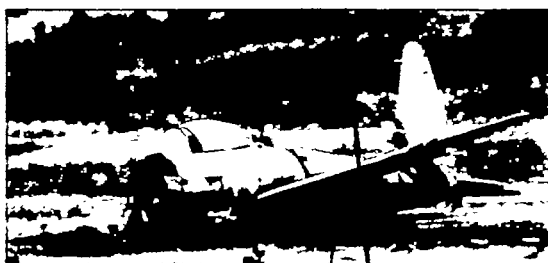
A second crash of an F-84 airplane equipped with the fire protection system was conducted, again with no fire occurring. When the airplane came to rest beyond the crash barrier, complete wetting of the airplane by the red-dyed fuel was observed (fig. 27).

FIGURE 27.—Extensive fuel wetting of F-84 following crash with inerting system.
